# Aqua Leak Detection

## Pool Inspection Report

Inspected on Fri, Jul 12 2019 at 10:40 AM

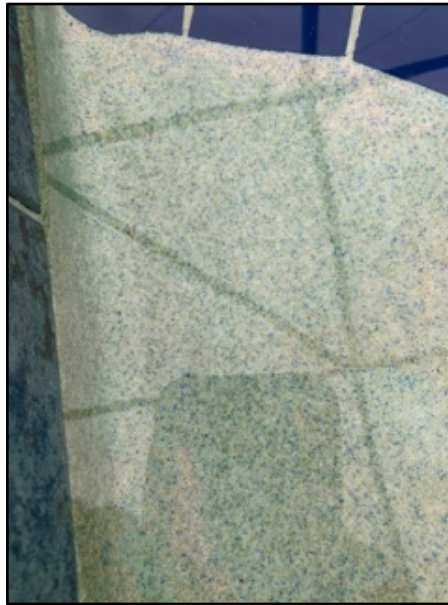
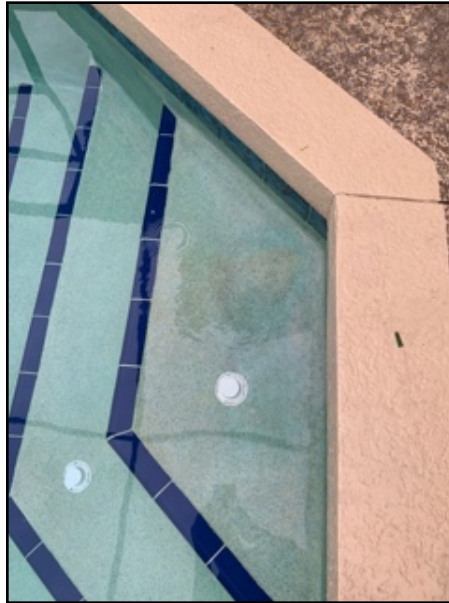
Condition: Minor cosmetic staining observed. These stains are solely cosmetic and not indications of structural flaws. As the surface ages, stains become more noticeable and frequent. Proper chemical treatment will alleviate the stains in the surface. No other issues observed, typical wear for the age of the pool.

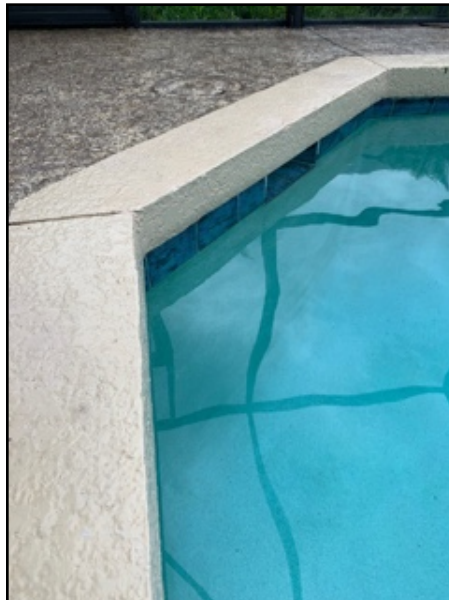
Coping appears to have very little wear. The deck as a hole appears to have very little cosmetic issues. No large cracks observed in coping or deck near the pool.

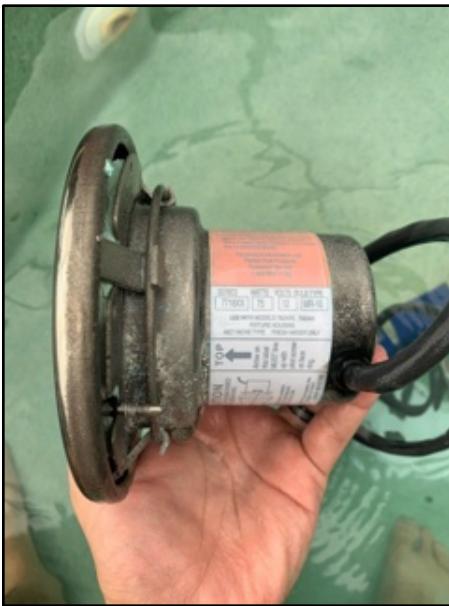
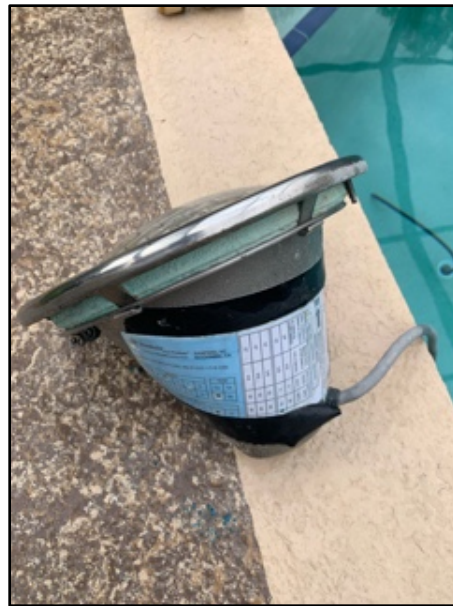
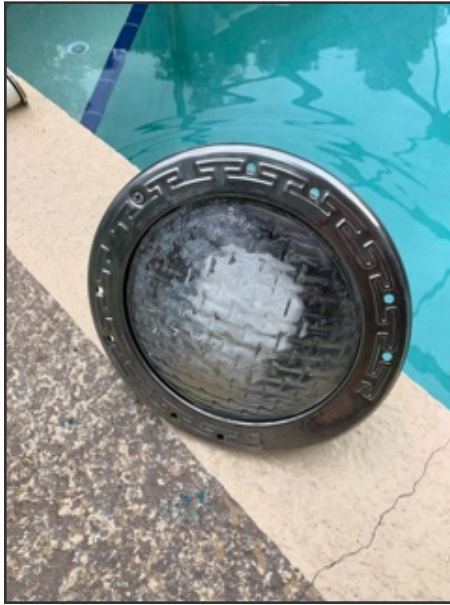
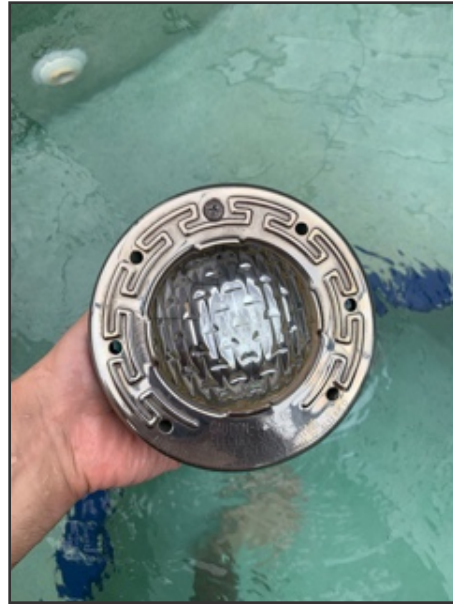
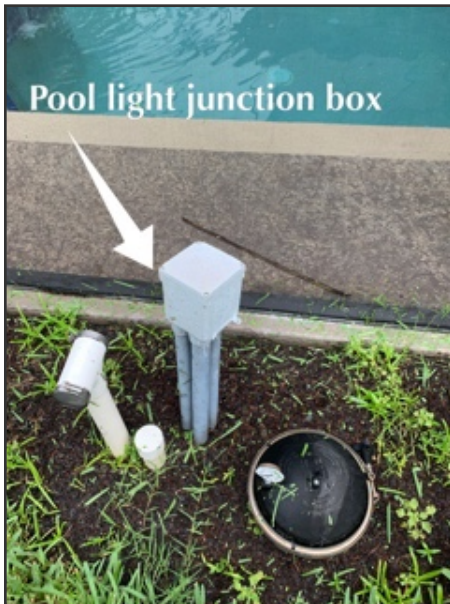
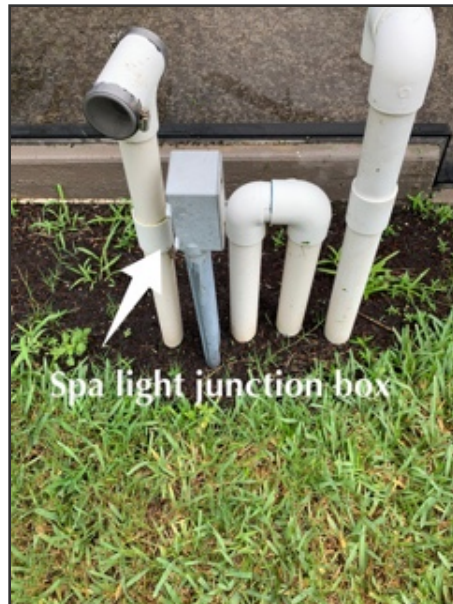
Condition: No leaks behind light in light niche. Gaskets on both light appear to be intact. Both light function properly when switch is toggled.

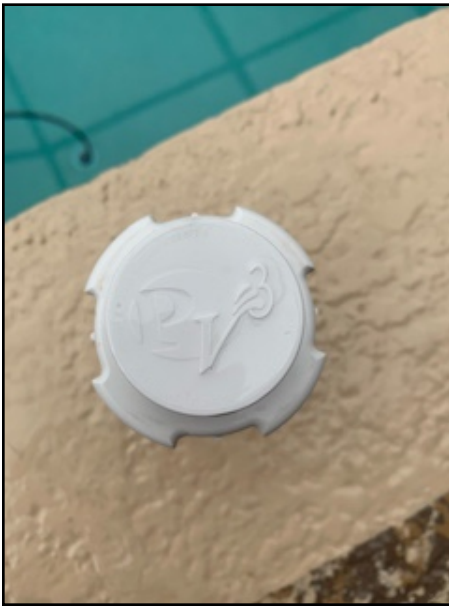
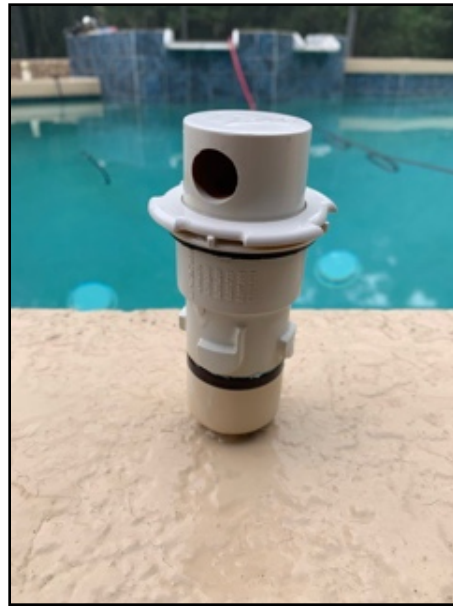
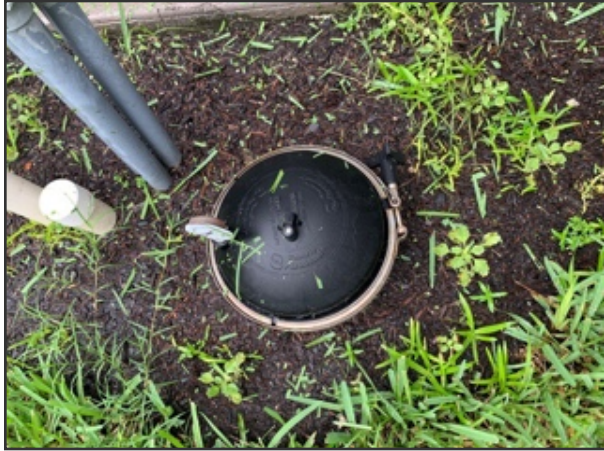
Condition: Floor system appears to operate properly. All head pop-up with flow. The floor system does not cycle from zone to zone, indicating that the gear pack needs to be serviced or replaced. The gear pack is located inside the black floor dome outside the cage (see picture). No leaks observed at the floor dome, indicating the gasket in the lid is not damaged or faulty.

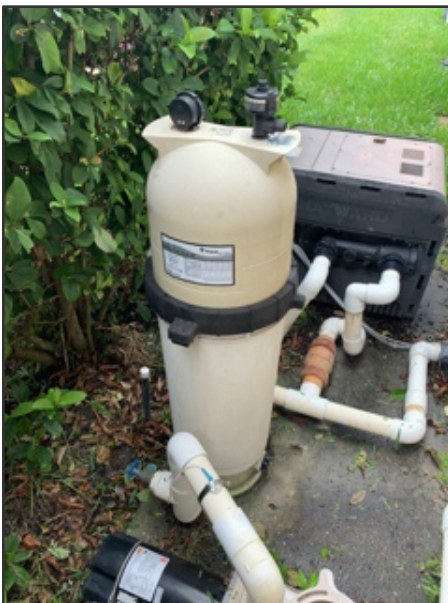
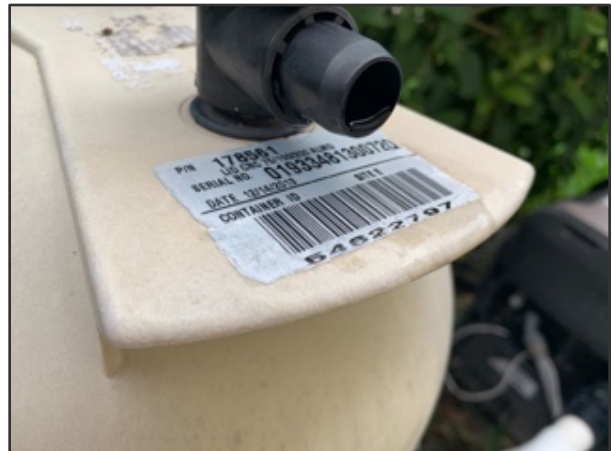
Condition: Typical wear for the age observed. No leaks at connections or lid gasket. Currently operating properly.

We recommend having the filter serviced upon taking possession of the pool. Often, it is difficult to tell exactly how clean the filter is without extensive tear down. Frequently, the pressure gauge on the filter is inaccurate or broken.

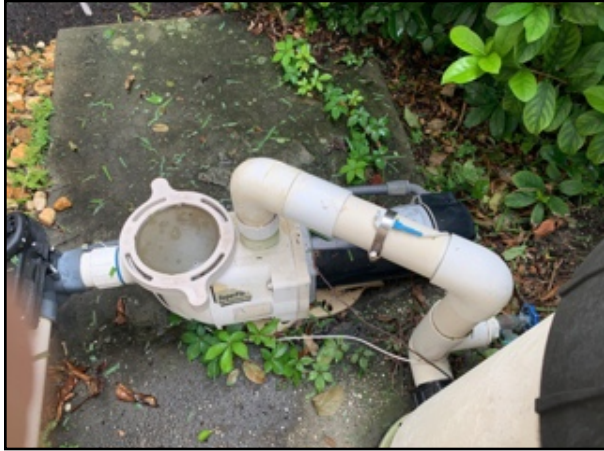
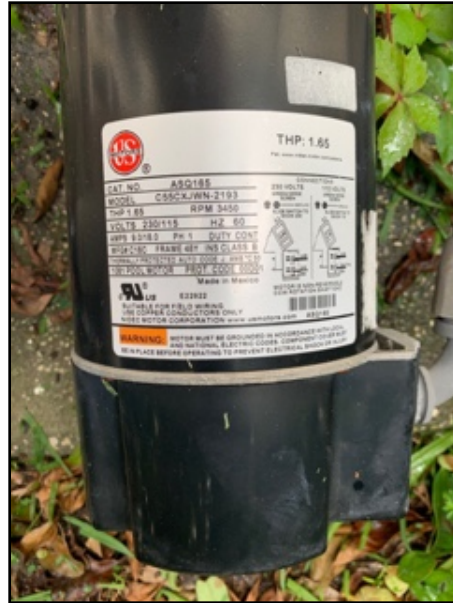
Pentair SuperFlo w/ 1.5HP Motor (U.S. Motors)  
Condition: Currently functioning properly. No leaks at make adapters or pump seals. No sound of grinding bearings observed.

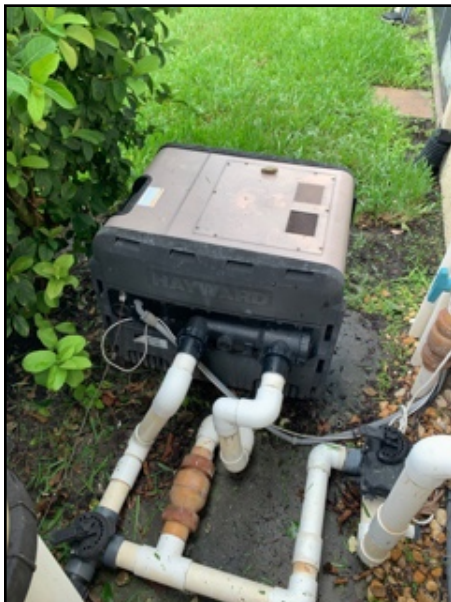
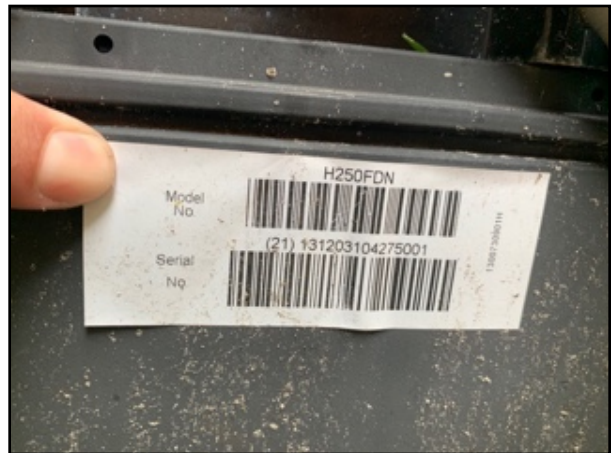
Hayward Propane Gas Heater  
Condition: Currently functioning properly. Newly installed gas line to heater. No leaks at connections. Typical wear for the age of the heater

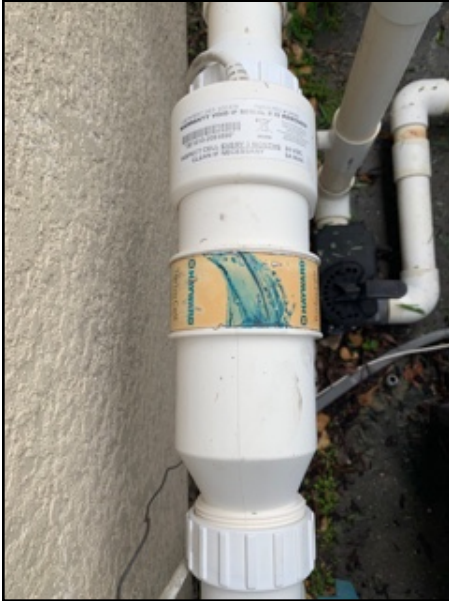
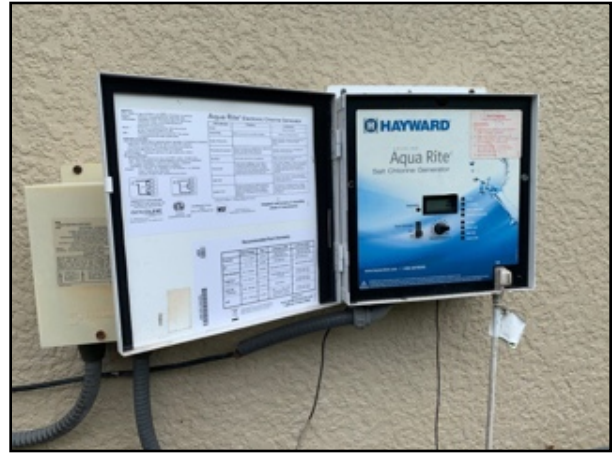
Hayward Gold Line Aqua Rite Salt Chlorine Generator  
Condition: Currently functioning properly. No observed defects. Minimal wear on the control panel and inline unit.

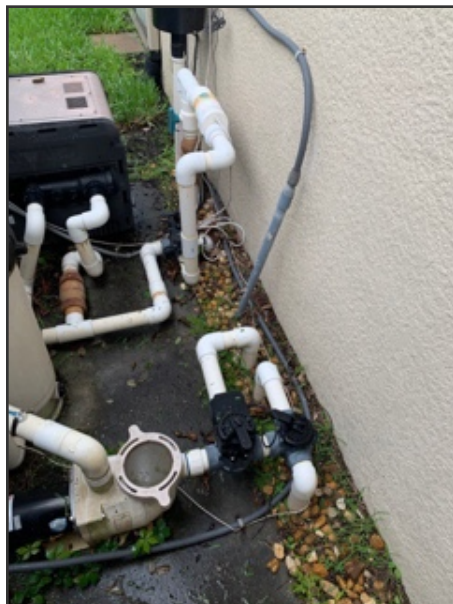
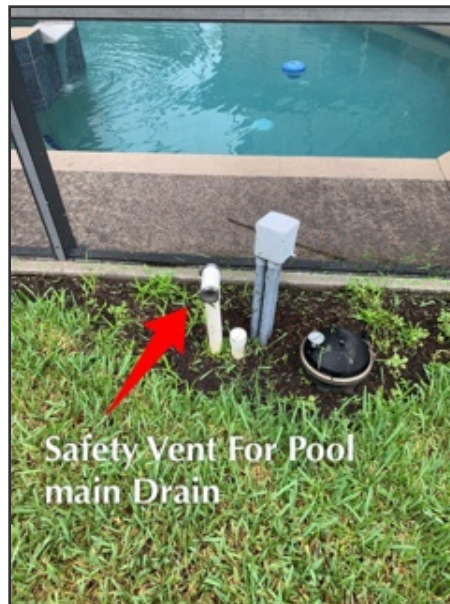
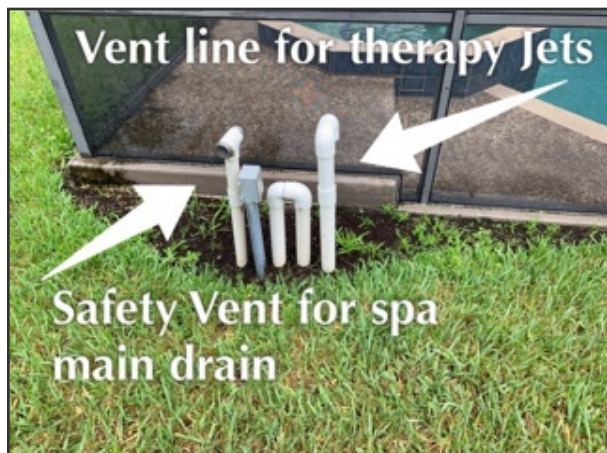
Pressure: Floor System, Spa Therapy Jets, Pool/Spa Common, Suction: Skimmer, Pool Main Drain, Spa Main Drain  
Condition: All plumbing was tested and held air pressure. No leaks. All valves at the equipment are functioning properly and no leaks observed at the pool equipment.

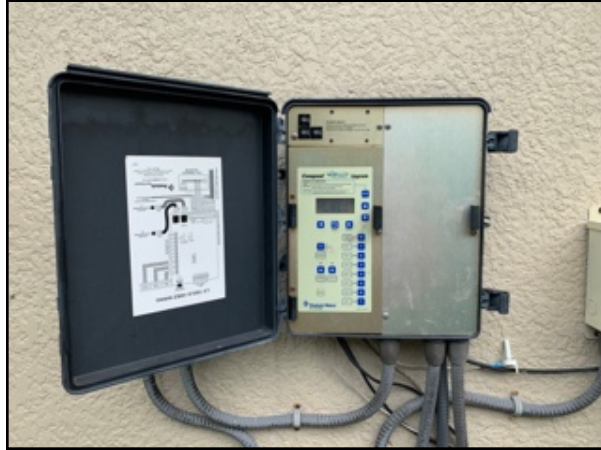
Compool EasyTouch Control Panel  
Condition: Currently functioning properly. Minimal wear inside cover. No observed defects.

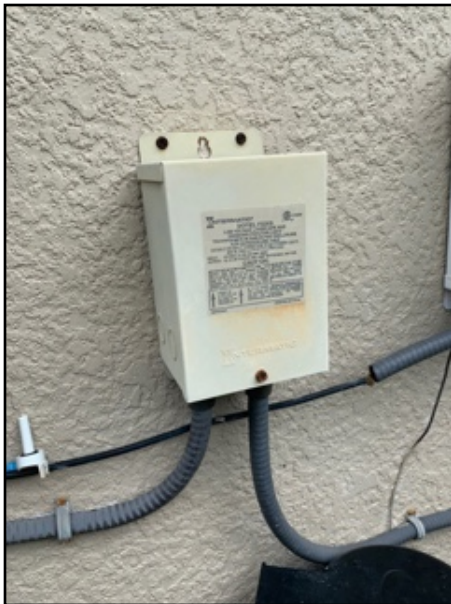
Figure 2-1

Comment 2:  
Pool lighting transformer. No observed defects.
