## Pre-Sale / Pre-Renovation Inspection Report

121 Sample Home  
Englewood, FL 34223

Inspected by Aqua Leak Detection

Prepared For: Customer Name  
Inspected on Wed, Aug 19, 2026 at 1:02 PM

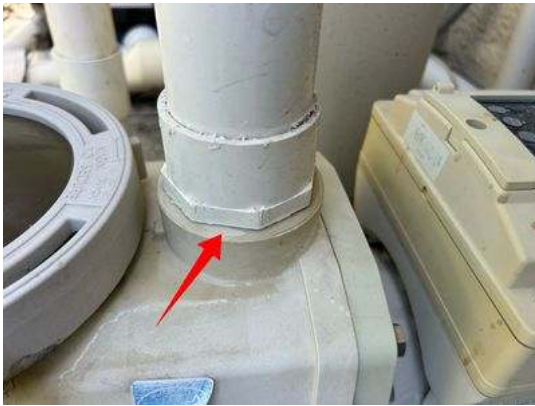
#### Comment 2

Leak found at top of pump male adaptor.

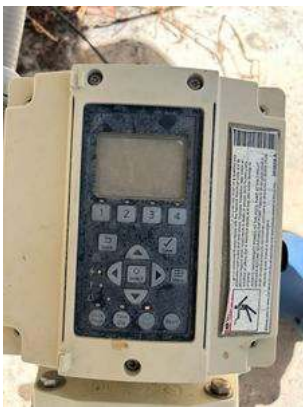
#### Comment 3

Unable to read pump display panel due to it being sun faded.

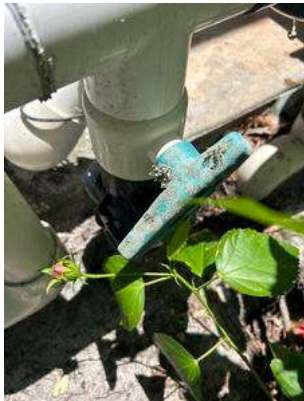
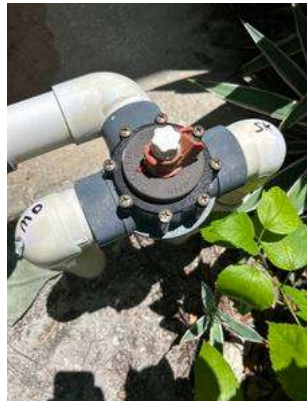
**Comment 7**

Valve handles for spa return & suction valves are brittle.

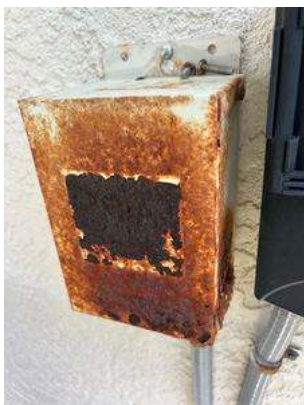
**Comment 9**

Visible rust located on pool transformer box.

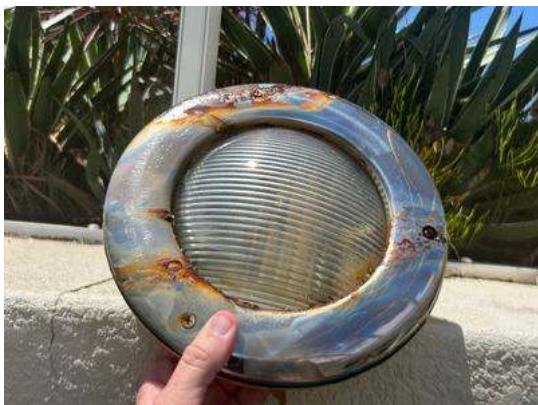
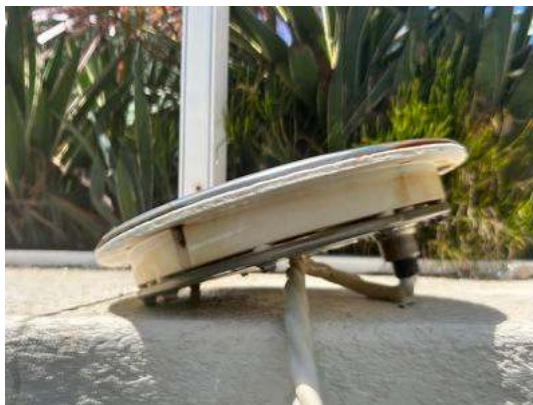
**Comment 10**

Visible moisture/rust located in pool light fixture. A bulb & seal replacement is needed.

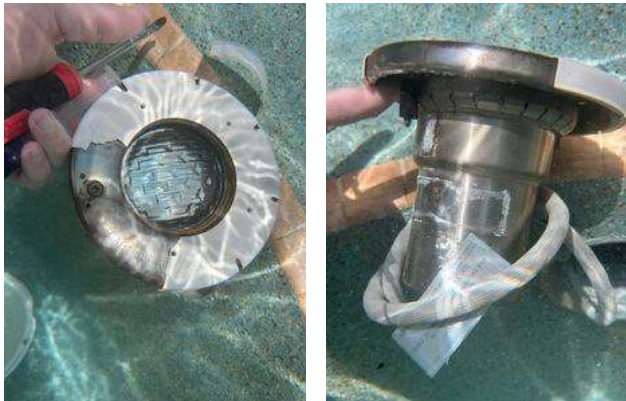
### Comment 11

Visible moisture located in spa light fixture. A bulb & seal replacement is needed.

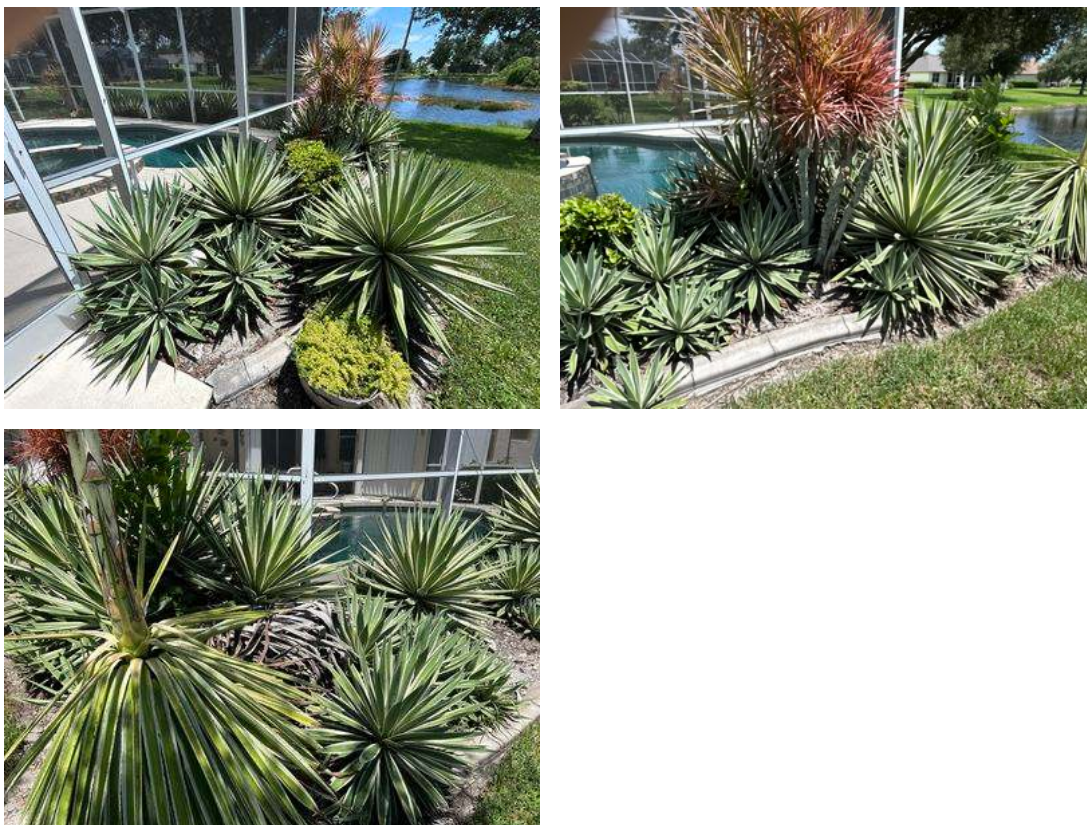
### Comment 12

Unable to locate where floor dome canister is due to vegetation around pool cage.

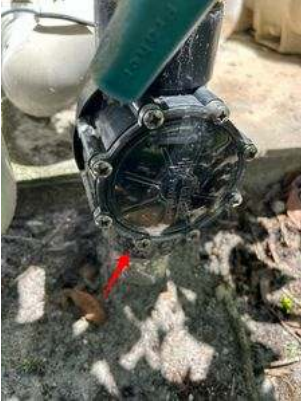
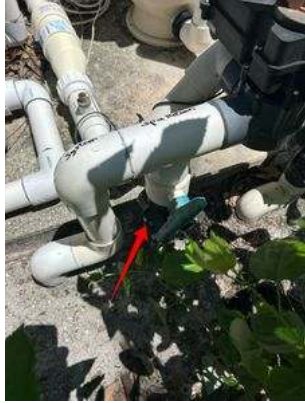
**Comment 16**

Bad check valve for spa return allows transfer into pool when equipment is off.

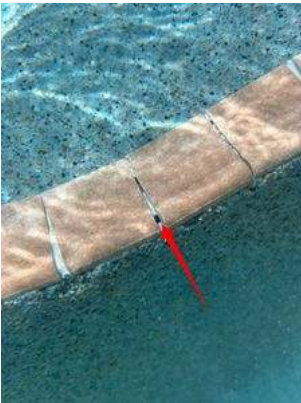
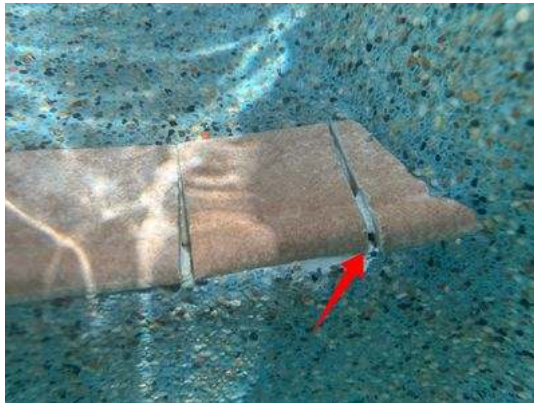
**Comment 22**

Leaks found at multiple spa bench tile/grout lines, patched with epoxy and quickset.

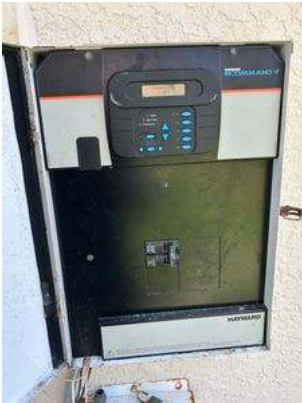
Timer / Control Panel turns on equipment and/or activates automation at time of inspection

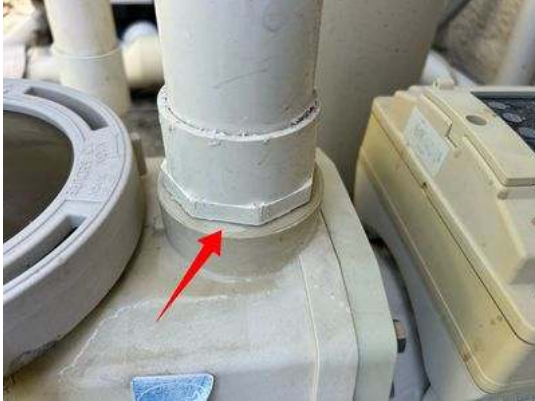
**Comment 2**

Leak found at top of pump male adaptor.

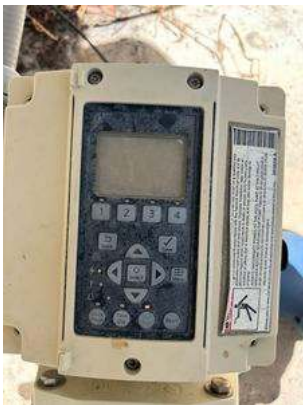
**Comment 3**

Unable to read pump display panel due to it being sun faded.

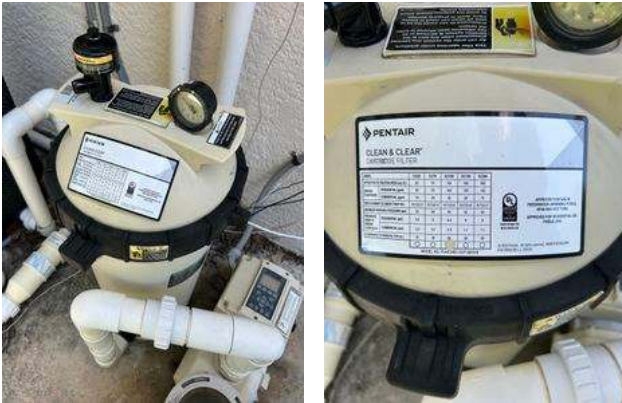
### Filter

Not leaking and appears functional at time of inspection

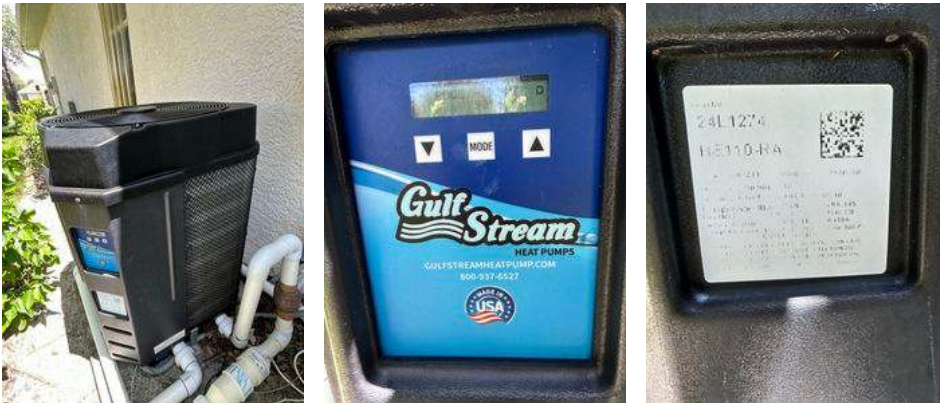
### Heater

Heater Type: Electric, Heater is operational responding to on board control panel or wall side control panel.

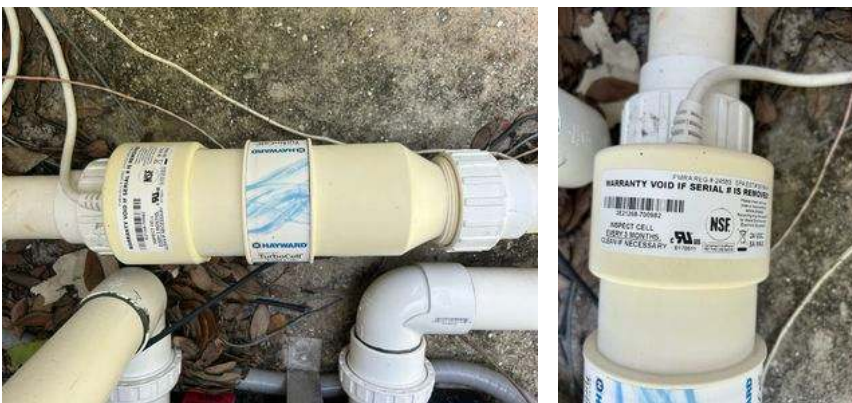
### Chemical Maintenance Device

Not leaking at time of inspection

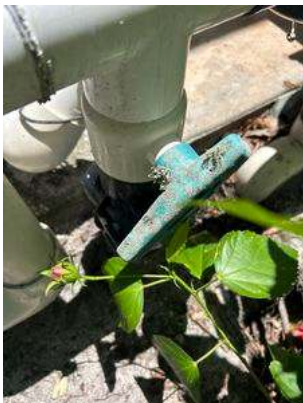
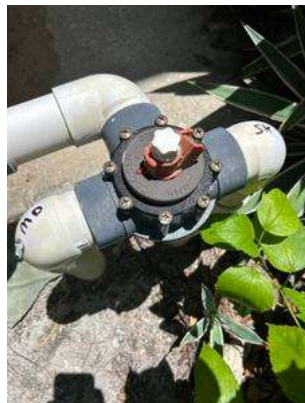
### **Comment 7 Deficiency**

Valves when left in the sun over time can become brittle and handles may break under normal operation. Aqua Leak Detection is not liable for broken valves/handles when operating them as intended.

Valve handles for spa return & suction valves are brittle.

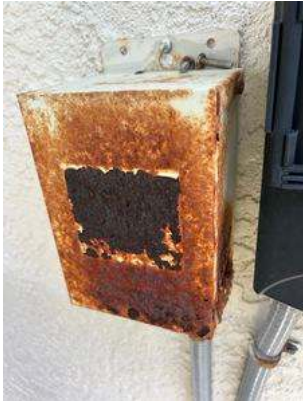
**Comment 9**

Visible rust located on pool transformer box.

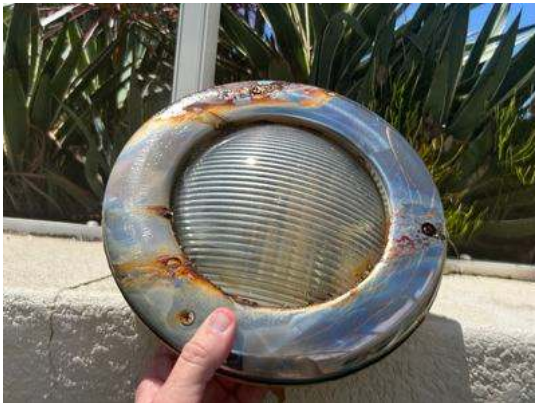
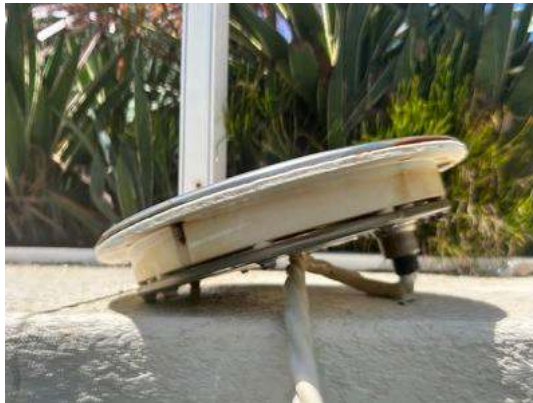
**Comment 10**

Visible moisture/rust located in pool light fixture. A bulb & seal replacement is needed.

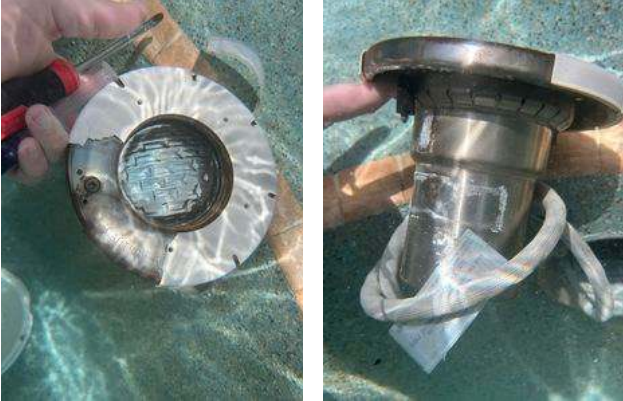
### Comment 11

Visible moisture located in spa light fixture. A bulb & seal replacement is needed.

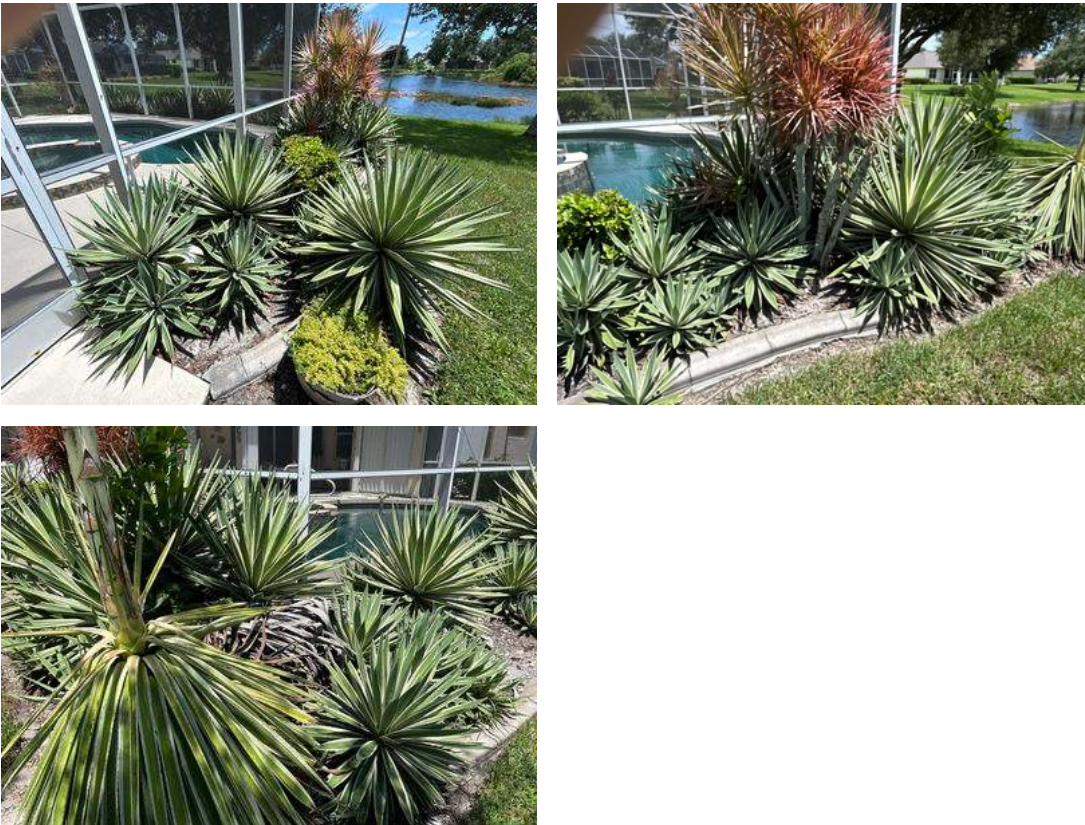
### Comment 12

Unable to locate where floor dome canister is due to vegetation around pool cage.

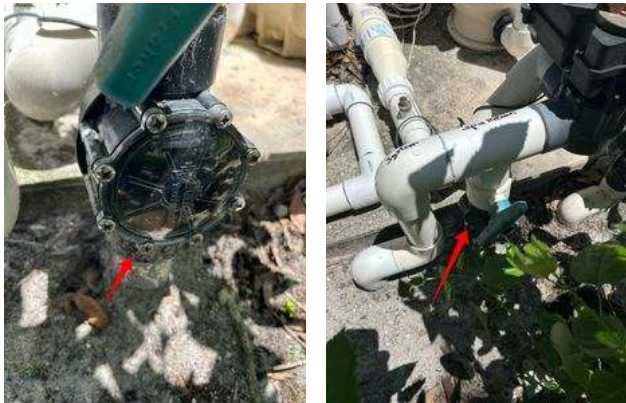
**Comment 16**

Bad check valve for spa return allows transfer into pool when equipment is off.

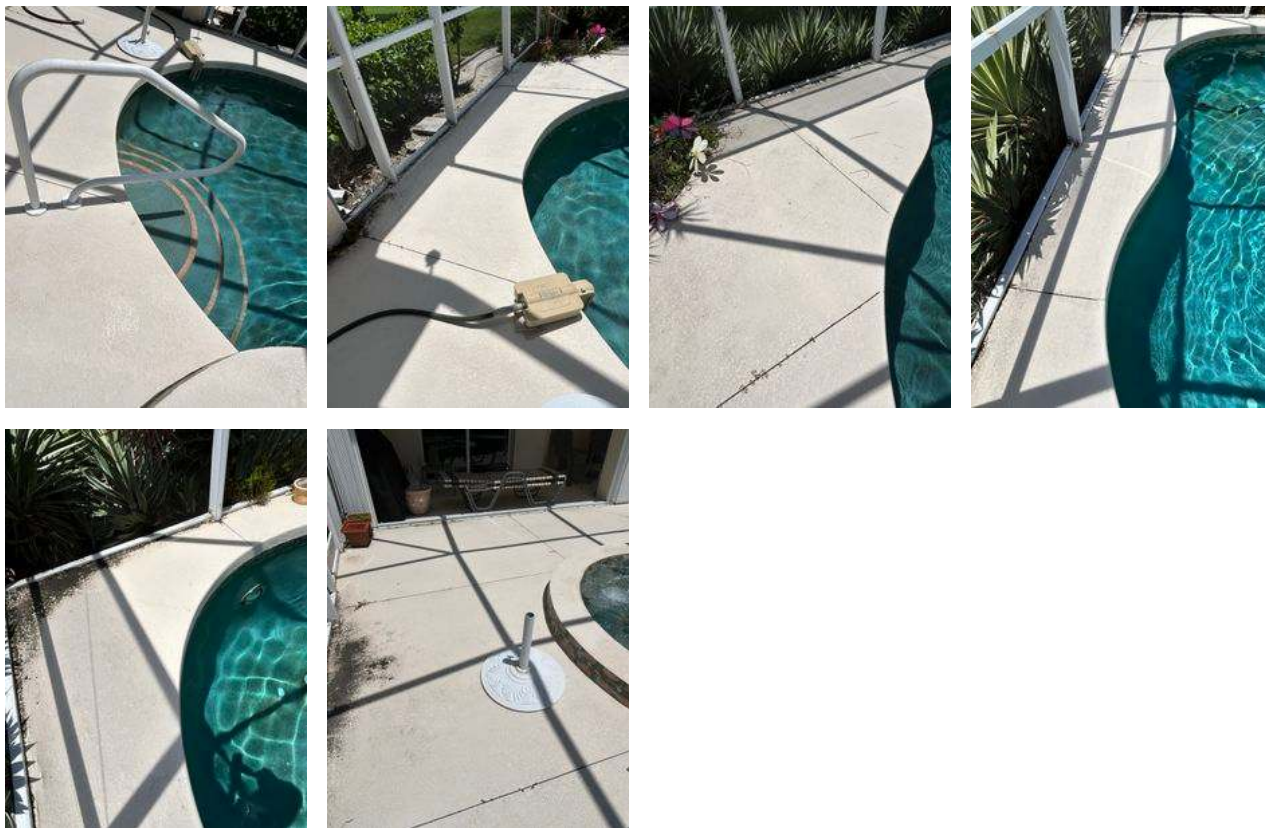
### Pool Deck Observations

No significant cracks or unusual settling observed at time of inspection.

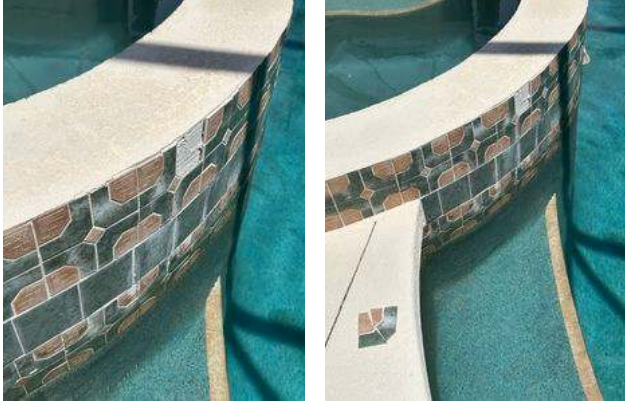
**Comment 19**  
**Information**

Visible missing tile located around spa.

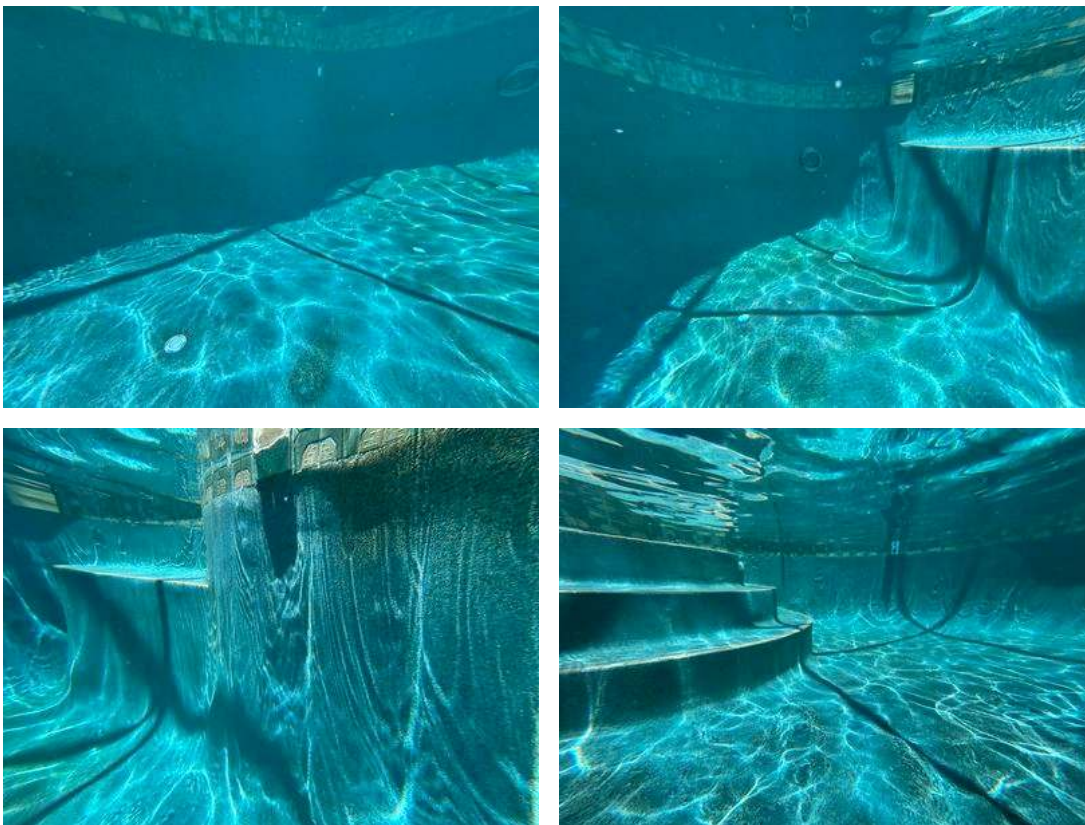
**Pool Surface Observations**

No cracks, pitting, calcium build up, or notable delamination observed at time of inspection.

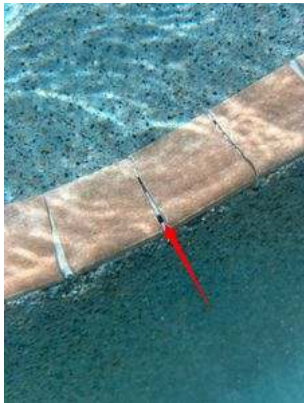
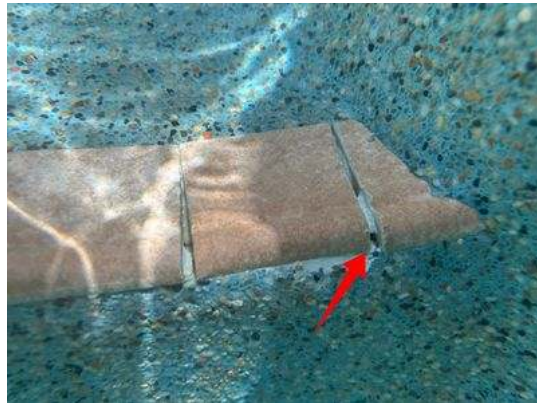
**Comment 22**

Leaks found at multiple spa bench tile/grout lines, patched with epoxy and quickset.

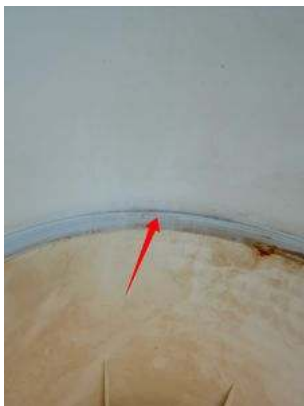
**Comment 23**

Visible stress crack located on skimmer canister, not actively leaking currently.

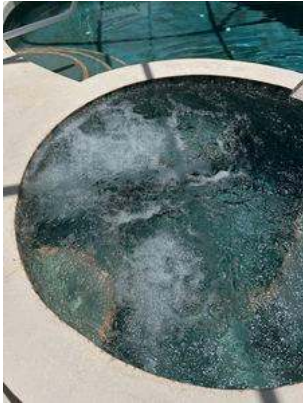
#### **Comment 27** **Information**

Spa therapy jets are operational.
